Accucraft Cab Forward (AC-12) Upgrade: Cross head and guide

Part Two- *Crosshead and lower guide removal:*

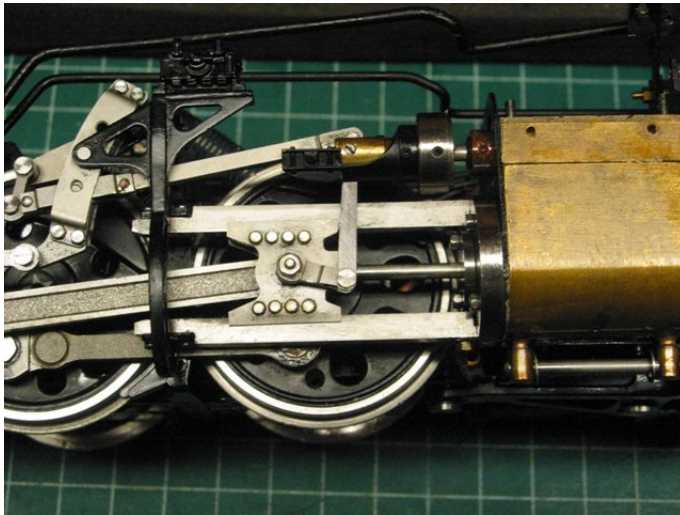
The main reason for upgrading the cross head is to correct the excess play in the crosshead-main rod connection and the lateral play that ensues.

OEM cross head is pictured above. Make note of the various positions of the different linkages and the relation of the crosshead to them.

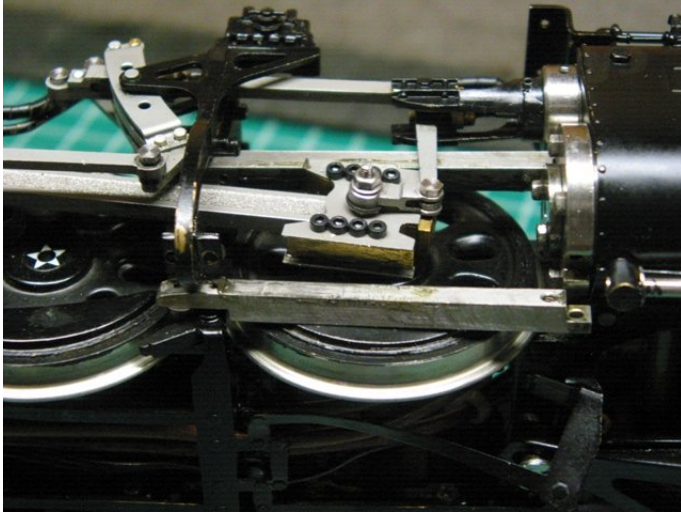
5. Bottom crosshead guide removed

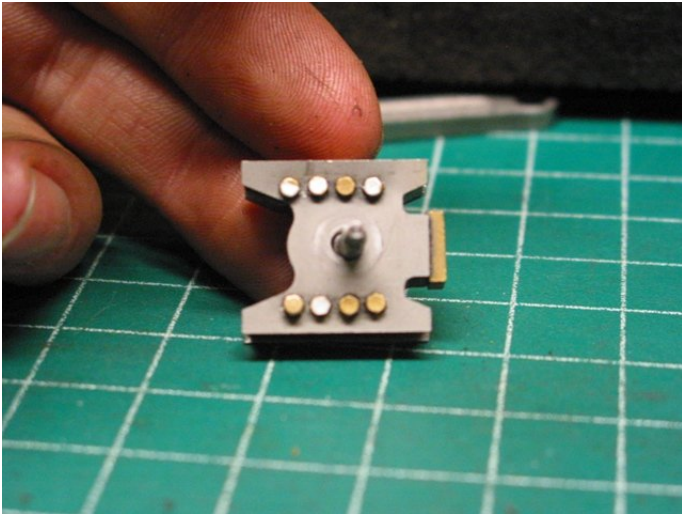
8. Cross head removed.
